[Docket No. FAA-2018-1046; Product Identifier 2018-CE-049-AD]

Airworthiness Directives; Piper Aircraft, Inc. Airplanes

ACTION: Notice of proposed rulemaking (NPRM).

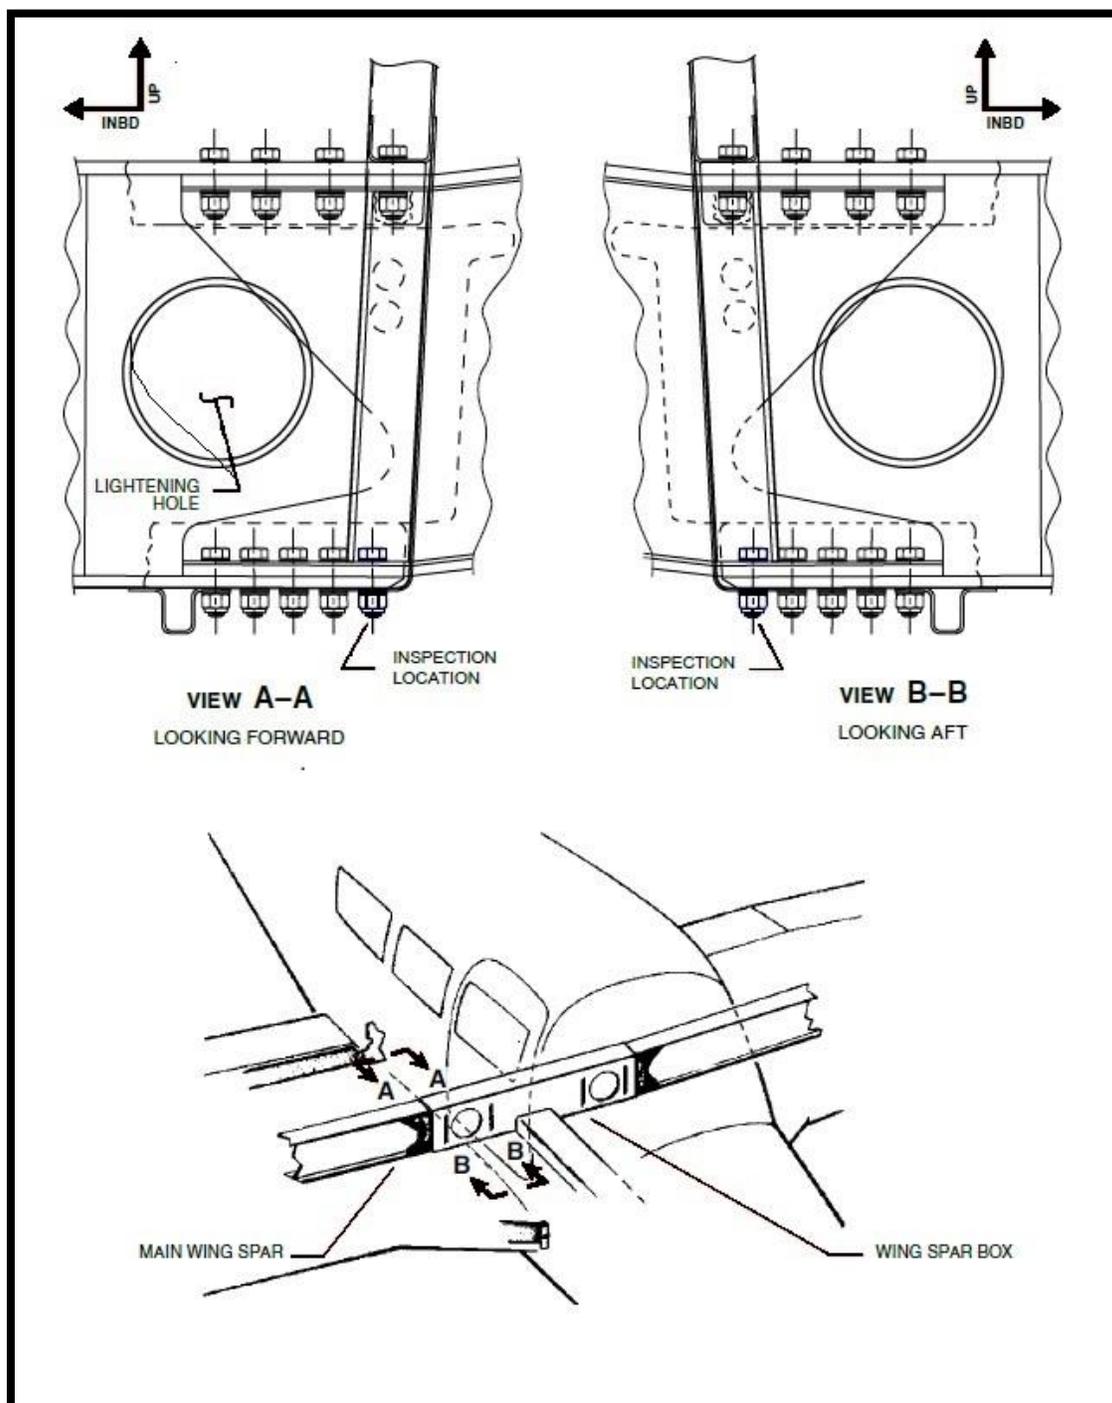
Figure 1. Main Spar Attach Bolt Locations (RH Side Shown)

This AD was prompted by a report of a fatigue crack found in a visually inaccessible area of the lower main wing spar cap. We are issuing this AD to detect and correct fatigue cracks in the lower main wing spar cap bolt holes. The unsafe condition, if not addressed, could result in the wing separating from the fuselage in flight.

(1) Locate the two (2) lower outboard main spar attach bolts, as shown in Figure 1 of Appendix 1, installed on the lower cap of the main spar, on the forward and aft sides of the spar web.

Within the compliance time specified in paragraph (h)(1) or (2) of this AD, eddy current inspect the inner surface of each bolt hole on the lower main wing spar cap for cracks by using the procedure in appendix 1 of this AD.

If a crack is found during an inspection required in paragraph (h) of this AD, before further flight, replace the main wing spar with a new (zero hours TIS) main wing spar or with a main wing spar that has been inspected as specified in appendix 1 of this AD and no cracks were found.
