Piper Aircraft, Inc.
2926 Piper Drive
Vero Beach, FL, U.S.A. 32960

SERVICE NO. 1345 BULLETIN

Date: March 27, 2020

MAIN WING SPAR INSPECTION

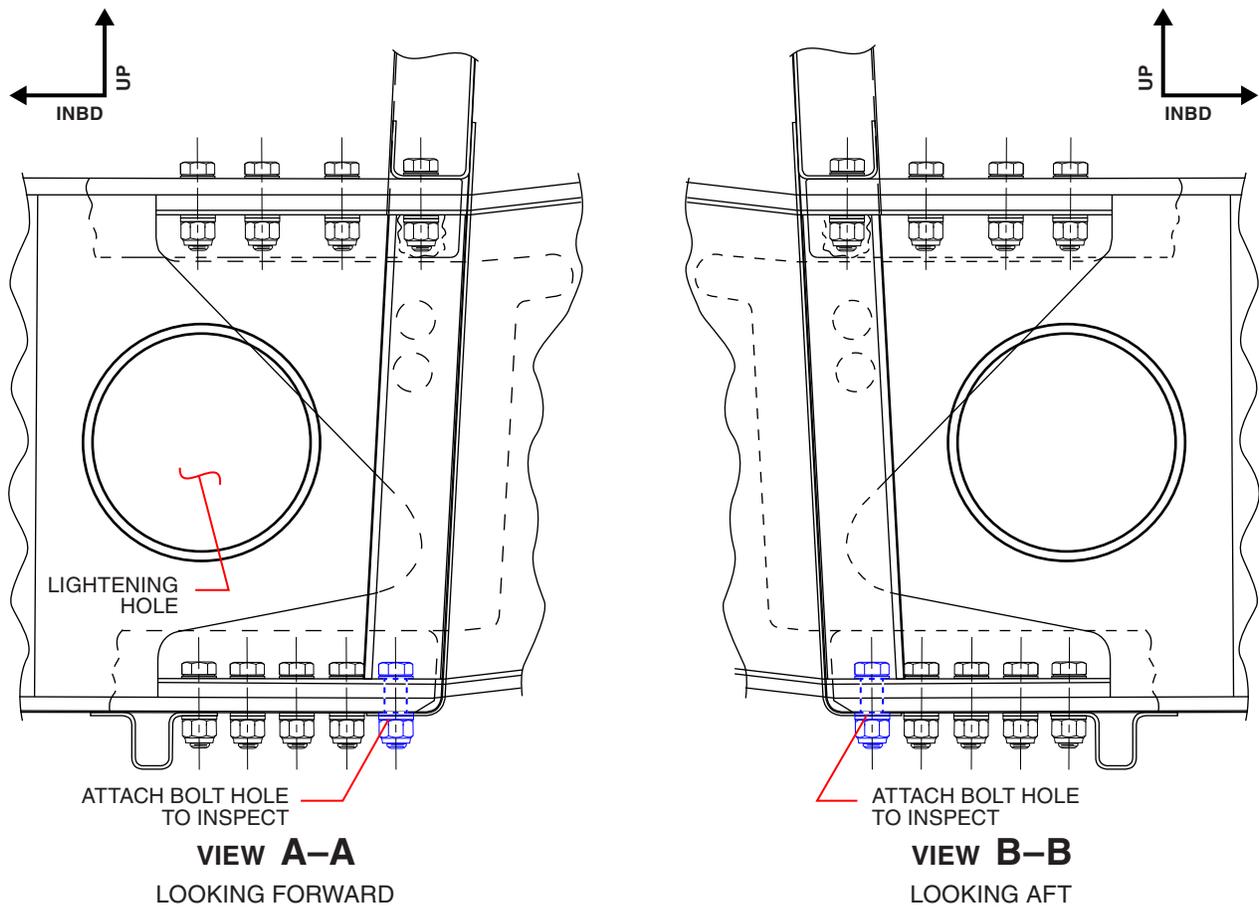
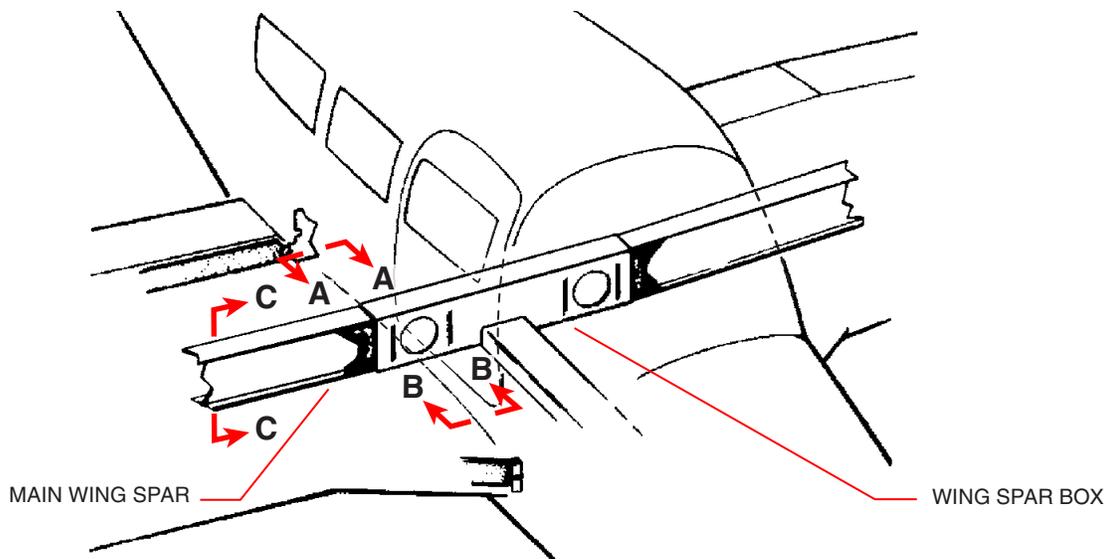
Figure 1, Sheet 1 of 2
Typical Main Wing Spar Attach Bolts and Spar Cross Section (Right Wing Shown)

1. Locate the two (2) outermost main spar attach bolts, as shown in Figure 1, installed on the lower cap of the left and right main spar, on the forward and aft sides of the spar web.

WARNING: Do not drive bolts into or out of the main spar attaching bolt holes (see Views A-A and B-B). Be careful to avoid damaging the bolt holes while removing and replacing the bolts.

2. Carefully remove the two (2) wing spar attach bolts. Discard the bolts and nuts. Retain or replace the washers, depending on condition.
3. Inspect the inner surface of each bolt hole using the eddy current inspection method described above. Figure 1 provides cross sections of the main wing spar showing the bolt holes to be inspected.
4. Fill out the inspection [feedback form \(link\)](#), regardless of the findings.
 - If no cracks are found, return the form to Piper within 10 business days. Proceed to Step 6.
 - If any cracks are found, return the form to Piper within 24 hours (or one business day). Proceed to Step 5.
5. Prior to further flight, replace the wing, spar or spar section, as applicable, with a serviceable unit that has been shown to be free of cracks when subjected to the inspections specified in this service bulletin.

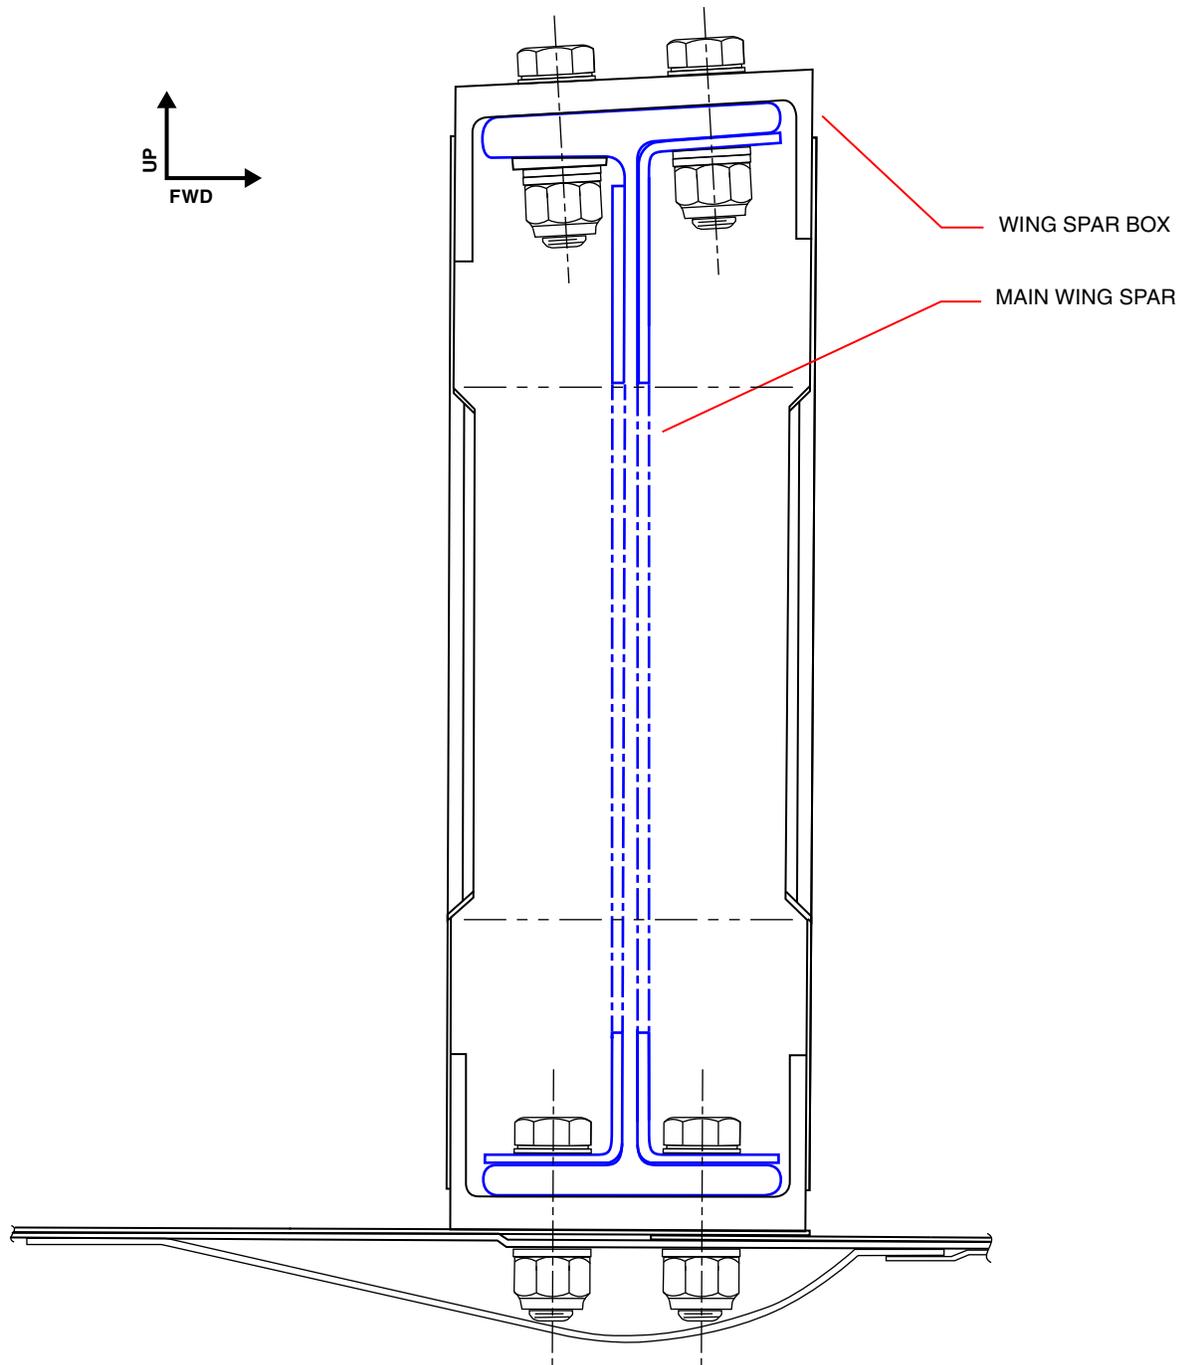
Figure 1, Sheet 2 of 2

VIEW C-C

WING SPAR CROSS SECTION
SHOWN AS INSTALLED IN WING SPAR BOX
